Flood Control Project Maintenance
Levee Inspections

Fall 2013 Levee Maintenance Deficiency Summary Report

Reclamation District No. 1001 Nicolaus

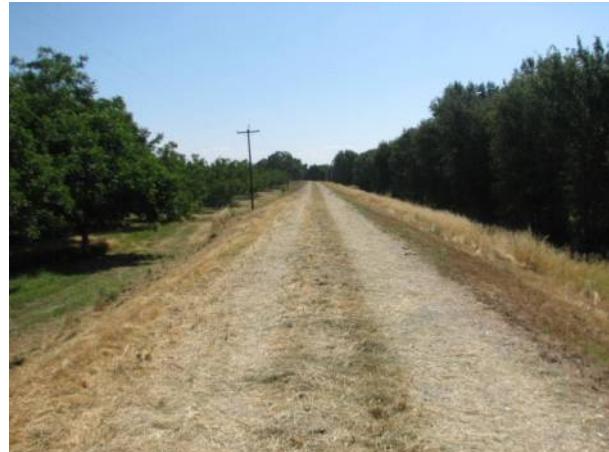
Levee Mile Report Line	6
Start Levee Mile	0.92
End Levee Mile	2.43
Location	Crown
Category	Earthen Levee
Item	Vegetation
The vegetation has been mowed needs to be controlled. Spring 2013	
mhoffman_f_20130917_143.JPG

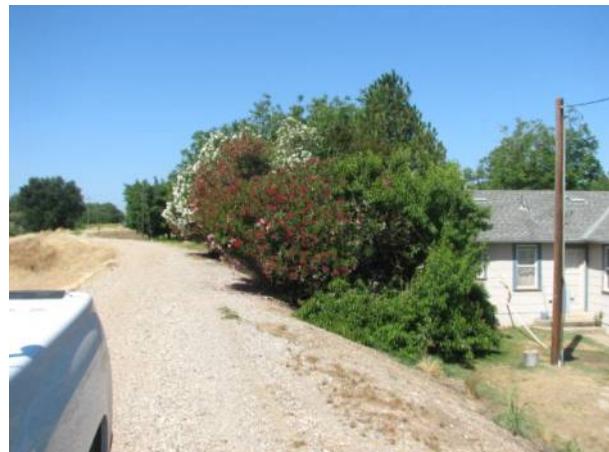
Levee Mile Report Line	7
Start Levee Mile	0.96
End Levee Mile	0.96
Location	Land Side
Category	Earthen Levee
Item	Vegetation
The landscape on the levee slope blocks visibility. Spring 2013	
mhoffman_f_20130917_145.JPG

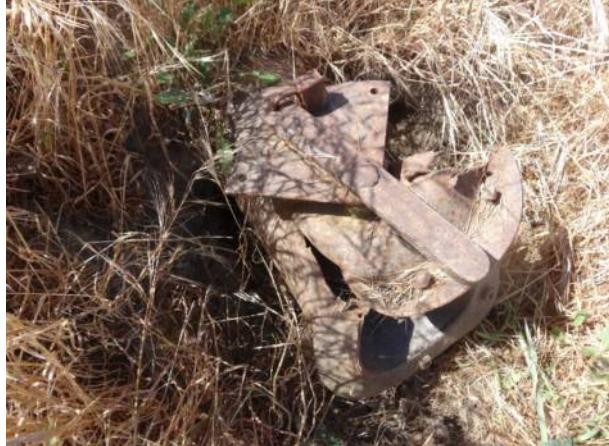
UCIP_7462.jpg

Levee Mile Report Line	2
Start Levee Mile	0.50
End Levee Mile	0.50
Location	Land Side
Category	Supplemental
Item	DWR UCIP Field Study
WS- end of the pipe.

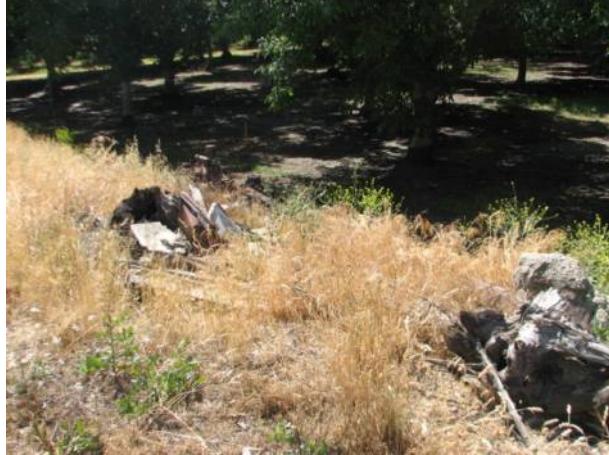
mhoffman_f_20130917_148.JPG

Levee Mile Report Line	3
Start Levee Mile	0.52
End Levee Mile	0.52
Location	Land Side
Category	Earthen Levee
Item	Encroachments
Debris on the levee slope and at the toe of the levee. Spring 2013

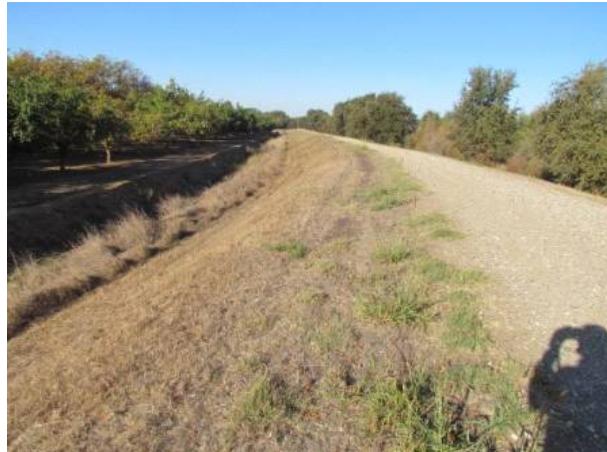
mhoffman_f_20131018_667.JPG

This photo was taken from the levee crown facing west looking down the landward slope at the acceptable vegetation maintenance.

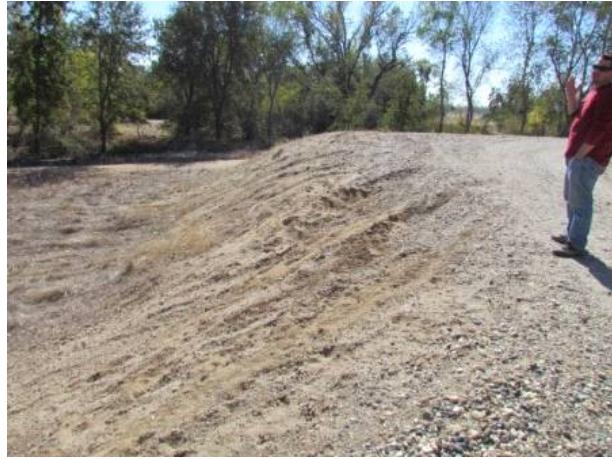
mhoffman_f_20131018_661.JPG

This photo was taken from the crown of the levee facing west looking down the slope at rutting caused by vehicles driving up the landward levee slope.

13	2.29	2.29	Earthen Levee	Slope Stability	LS A/W Ma	S3 : Repair the levee slope damaged by vehicle traffic and prevent access where possible.	38.996302 ° -121.412285 °	38.996302 ° -121.412285 °	30	DWR ID: DWR_RD1001_03_s_2013_30	Y

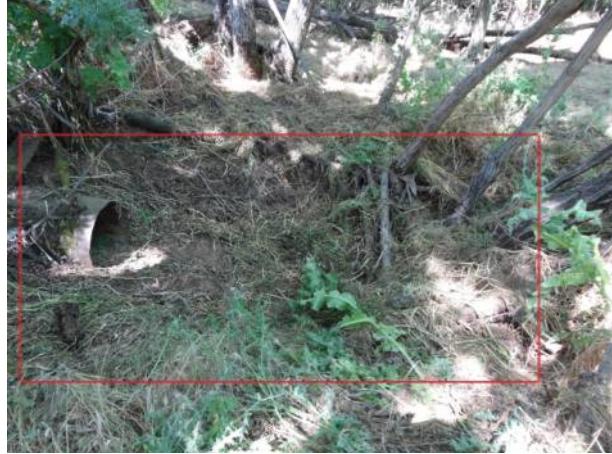
UCIP_7559.jpg

Levee Mile Report Line	5
Start Levee Mile	0.88
End Levee Mile	0.88
Location	Crown
Category	Supplemental
Item	DWR UCIP Field Study

WS- abandoned CMP and depression around it.

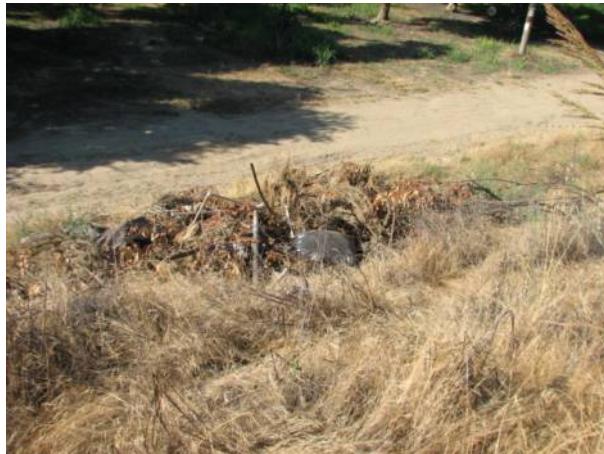
Levee Mile Report Line	19
Start Levee Mile	3.03
End Levee Mile	3.03
Location	Land Side
Category	Earthen Levee
Item	Encroachments
Pruning pile on the levee slope. Spring 2013	
mhoffman_f_20130917_189.JPG

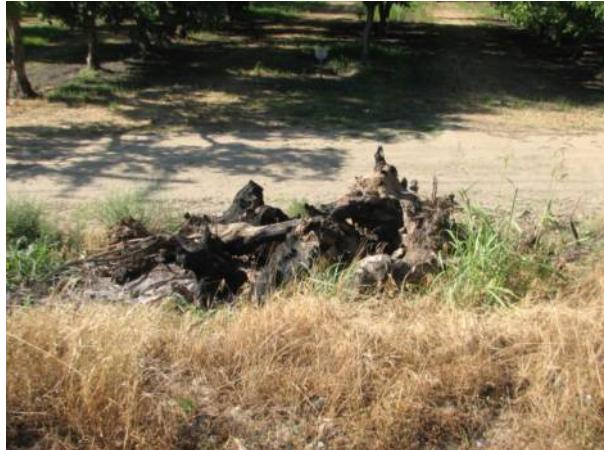
Levee Mile Report Line	21
Start Levee Mile	3.16
End Levee Mile	3.16
Location	Land Side
Category	Earthen Levee
Item	Encroachments
Stumps and pruning piled on the levee slope. Spring 2013	
mhoffman_f_20130917_190.JPG

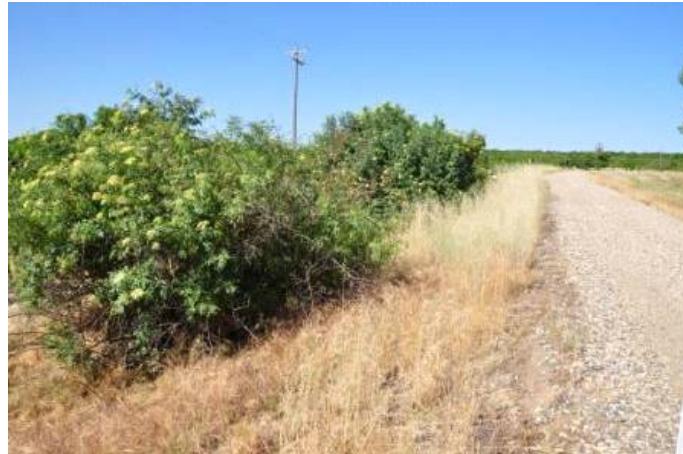
mhoffman_f_20130917_200.JPG

RD 1001 Unit 3 - L/S slope -Elderberries

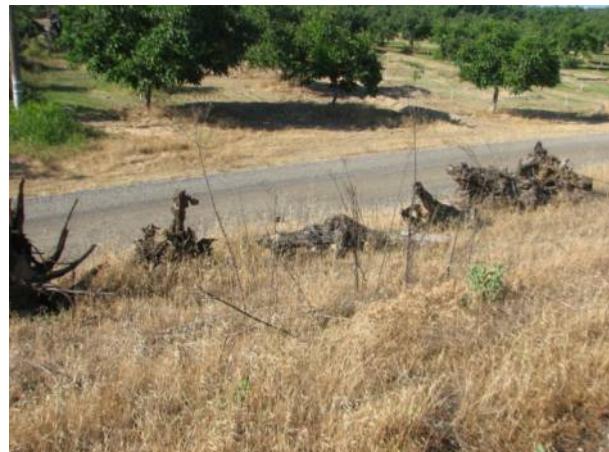
mhoffman_f_20130917_191.JPG

Levee Mile Report Line	23
Start Levee Mile	3.59
End Levee Mile	3.59
Location	Land Side
Category	Earthen Levee
Item	Encroachments

Walnut root balls at the levee toe. Spring 2013

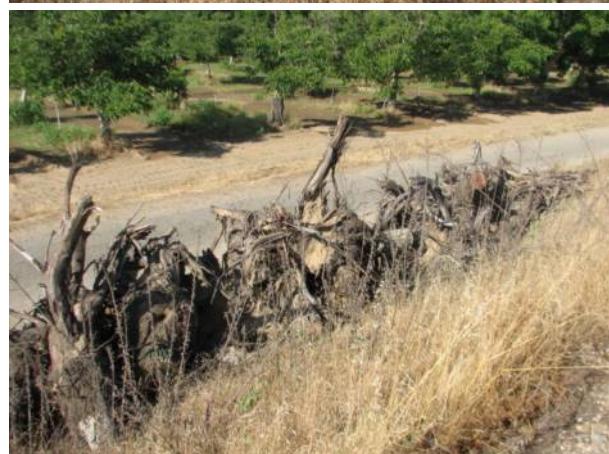
mhoffman_f_20130917_192.JPG

Levee Mile Report Line	24
Start Levee Mile	3.71
End Levee Mile	3.71
Location	Land Side
Category	Earthen Levee
Item	Encroachments

Walnut stumps at the levee toe. Spring 2013

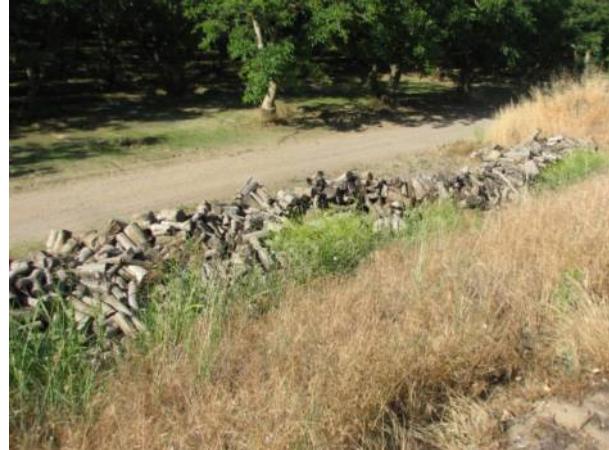
Levee Mile Report Line	25
Start Levee Mile	3.84
End Levee Mile	3.84
Location	Land Side
Category	Earthen Levee
Item	Encroachments
Firewood piled up at the levee toe. Spring 2013	
mhoffman_f_20130917_193.JPG

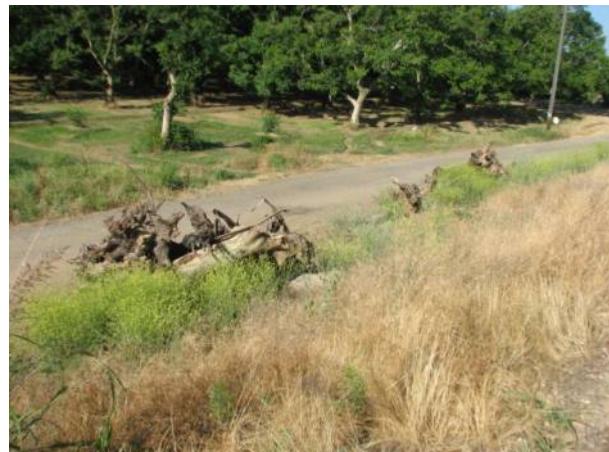
Levee Mile Report Line	26
Start Levee Mile	3.95
End Levee Mile	3.95
Location	Land Side
Category	Earthen Levee
Item	Encroachments
Walnut stumps at the levee toe. Spring 2013	
mhoffman_f_20130917_160.JPG

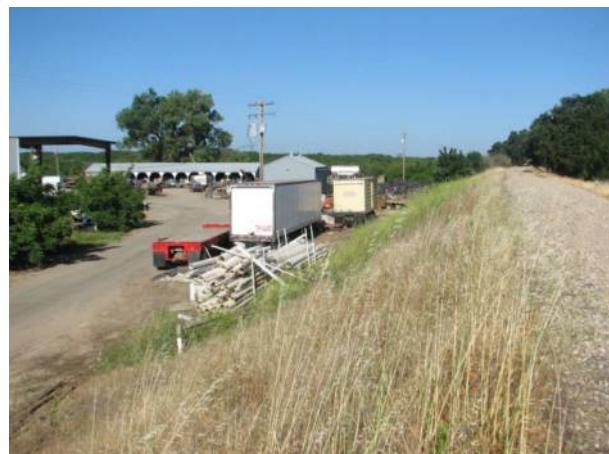
Levee Mile Report Line	27
Start Levee Mile	4.05
End Levee Mile	4.11
Location	Land Side
Category	Earthen Levee
Item	Encroachments
Irrigation pipe equipment and plastic cans within the easement of the levee. Spring 2013	
mhoffman_f_20130917_161.JPG

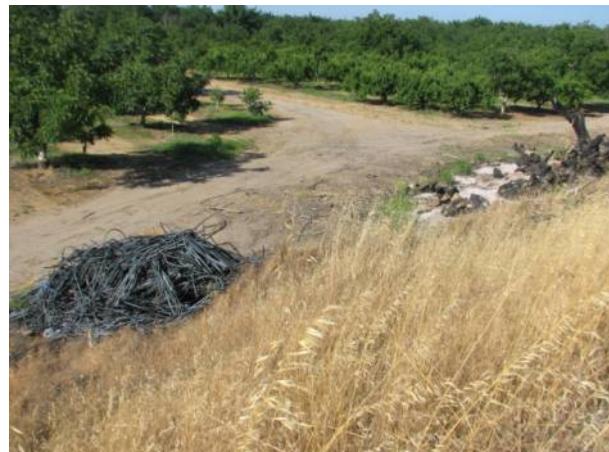
mhoffman_f_20130917_163.JPG

Drip irrigation tubing within the easement of the levee. Spring 2013

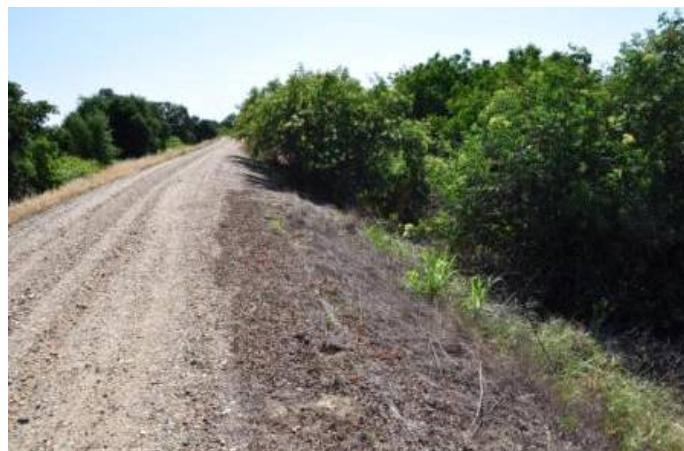
mhoffman_f_20130917_198.JPG

Levee Mile Report Line	30
Start Levee Mile	4.68
End Levee Mile	4.68
Location	Land Side
Category	Earthen Levee
Item	Vegetation

RD 1001 Unit 3 - W/S slope -Elderberries

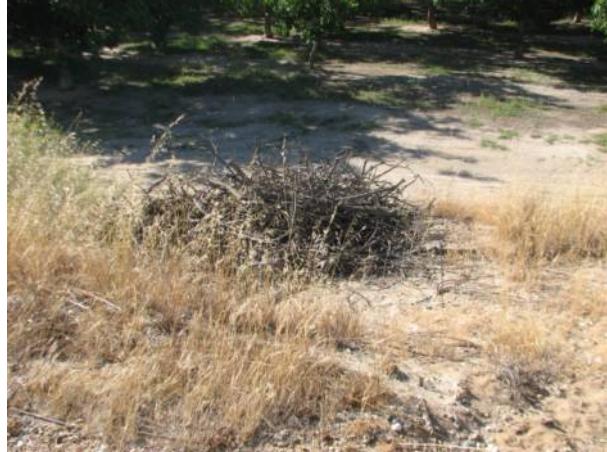
Levee Mile Report Line	32
Start Levee Mile	4.75
End Levee Mile	4.75
Location	Land Side
Category	Earthen Levee
Item	Encroachments
Small pruning pile at toe of levee. Spring 2013	
mhoffman_f_20130917_194.JPG

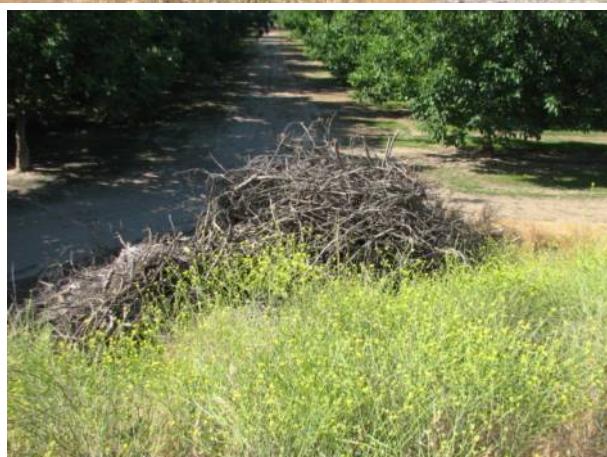
Levee Mile Report Line	34
Start Levee Mile	4.99
End Levee Mile	4.99
Location	Land Side
Category	Earthen Levee
Item	Encroachments
Pruning pile at toe of the levee. Spring 2013	
mhoffman_f_20130917_171.JPG

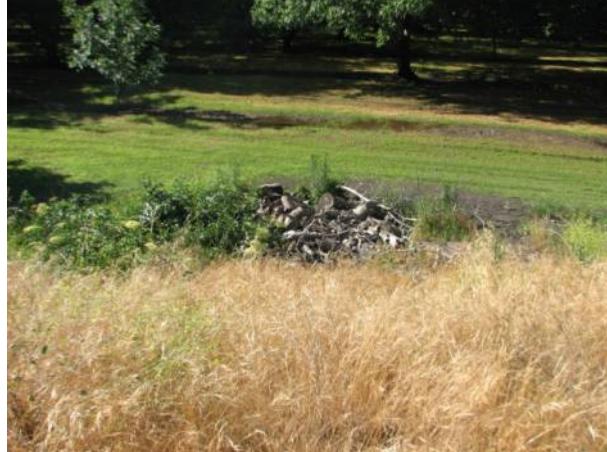
Levee Mile Report Line	36
Start Levee Mile	5.67
End Levee Mile	5.67
Location	Land Side
Category	Earthen Levee
Item	Encroachments
Pruning pile within the easement of the levee. Spring 2013	
mhoffman_f_20130917_162.JPG

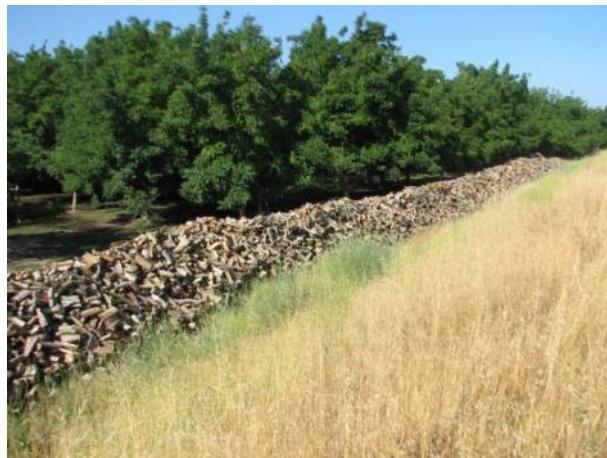
Levee Mile Report Line	37
Start Levee Mile	6.17
End Levee Mile	6.23
Location	Land Side
Category	Earthen Levee
Item	Encroachments
A very neat stack of firewood within the easement of the levee. Spring 2013	
mhoffman_f_20130917_195.JPG

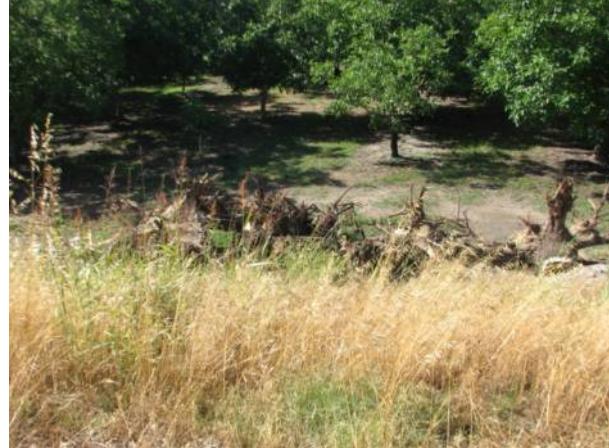
Levee Mile Report Line	39
Start Levee Mile	6.88
End Levee Mile	6.88
Location	Land Side
Category	Earthen Levee
Item	Encroachments
Walnut stumps within the easement of the levee. Spring 2013	mhoffman_f_20130917_197.JPG

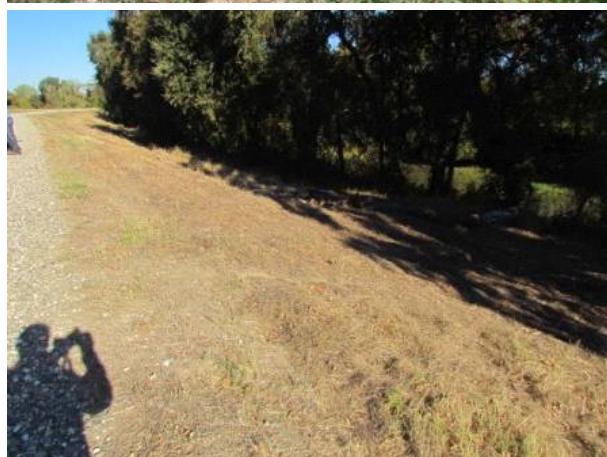
Levee Mile Report Line	41
Start Levee Mile	9.68
End Levee Mile	9.68
Location	Water Side
Category	Earthen Levee
Item	Encroachments
This photo was taken from the levee crown facing west looking down the waterward slope at a tree that had fallen down.	
mhoffman_f_20131018_664.JPG

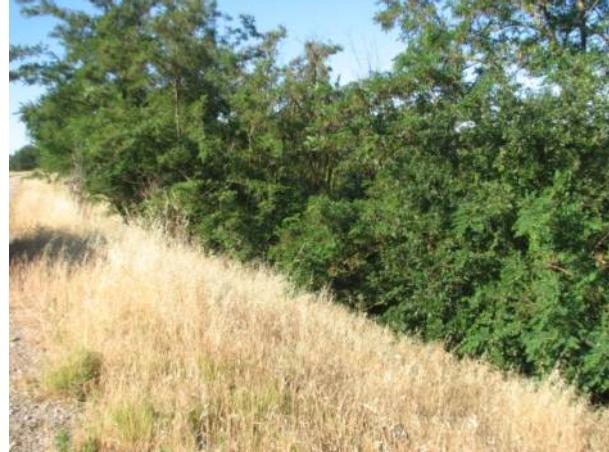
Levee Mile Report Line	42
Start Levee Mile	10.22
End Levee Mile	10.22
Location	Water Side
Category	Earthen Levee
Item	Trim / Thin Trees
Trees partially obstruct visibility. Spring 2013	
mhoffman_f_20130917_180.JPG

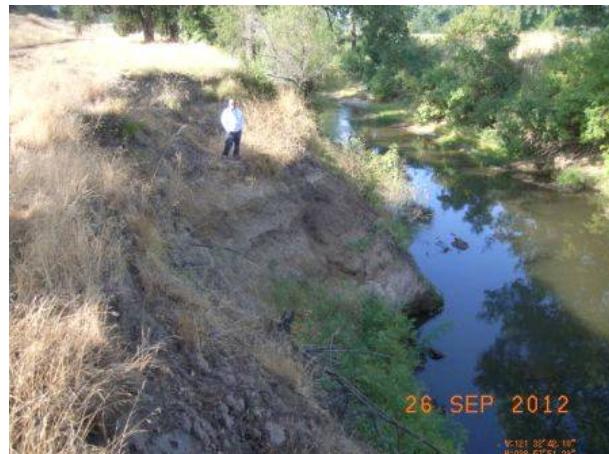
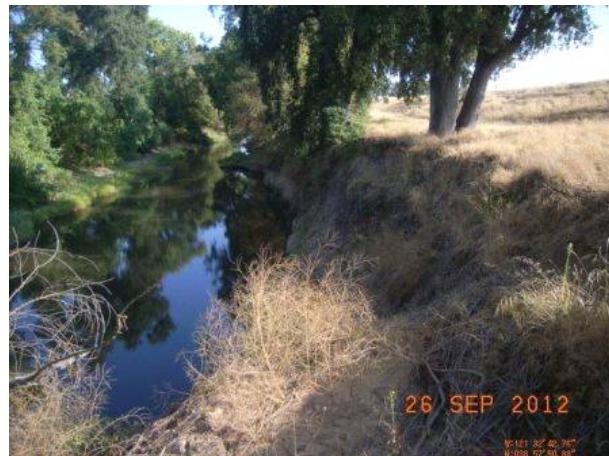
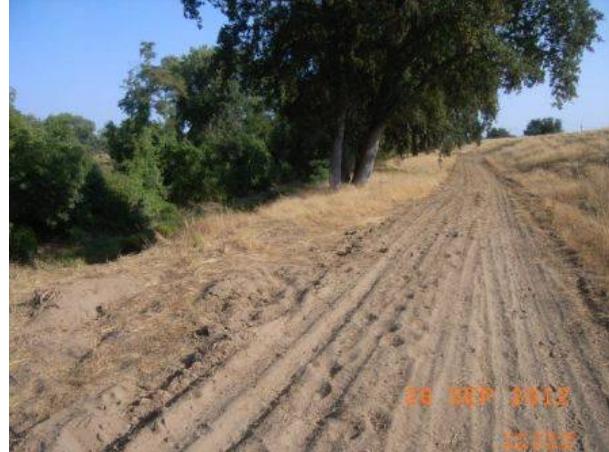
43	10.37	10.41	Supplemental USACE Erosion Survey	WS	M	Ma	Inspector Comments: 2011 - Large section of bank has slumped off. RD has flagged and appears to be watching. 2012: No observed change. [2012 Site ID: BER_2-5_L]	38.964583 °	38.964010 °	17 -121.544967 ° -121.545228 ° Y DWR ID:

Levee Mile Report Line	43
Start Levee Mile	10.37
End Levee Mile	10.41
Location	Water Side
Category	Supplemental
Item	USACE Erosion Survey
USACE 2012 Photo #1

Levee Mile Report Line	43
Start Levee Mile	10.37
End Levee Mile	10.41
Location	Water Side
Category	Supplemental
Item	USACE Erosion Survey
USACE2013_BER_2-5_L_1.jpg

Levee Mile Report Line	43
Start Levee Mile	10.37
End Levee Mile	10.41
Location	Water Side
Category	Supplemental
Item	USACE Erosion Survey
USACE 2012 Photo #3	
USACE2013_BER_2-5_L_3.jpg

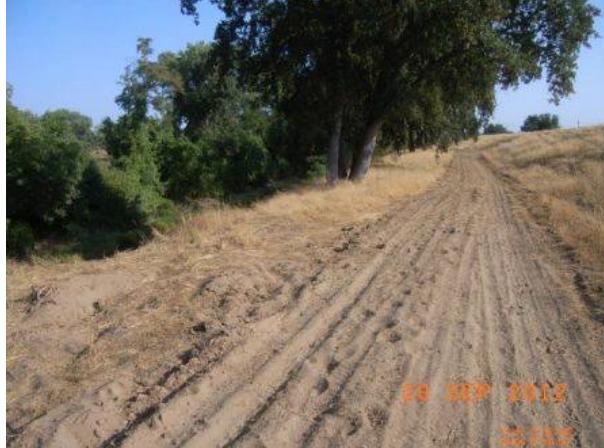
mhoffman_f_20130917_170.jpg

Levee Mile Report Line	44
Start Levee Mile	10.60
End Levee Mile	10.60
Location	Water Side
Category	Earthen Levee
Item	Encroachments

USACE 2012 Photo #3

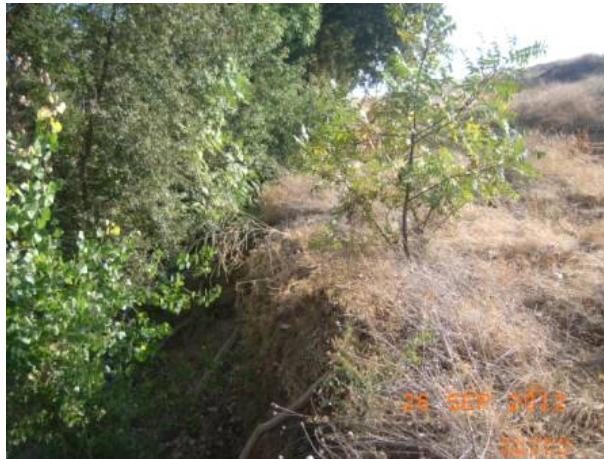
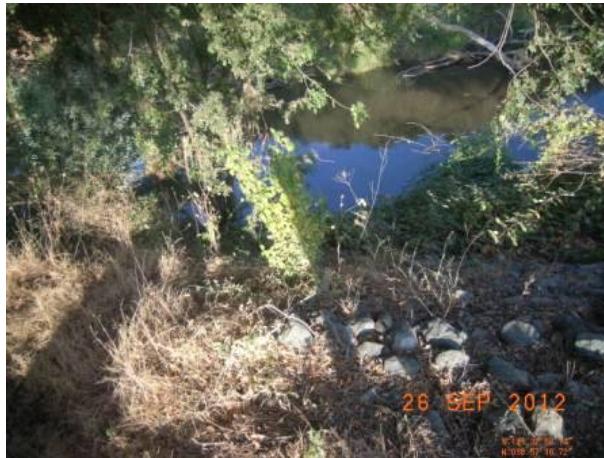
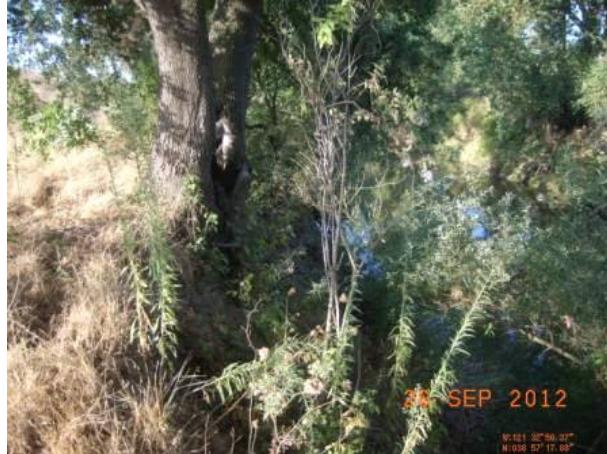
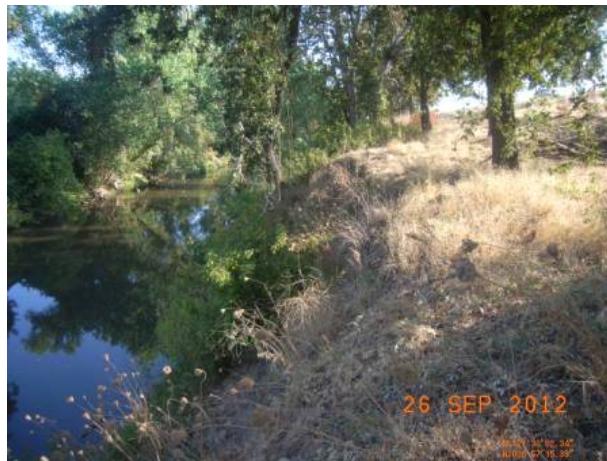
Levee Mile Report Line	46
Start Levee Mile	11.09
End Levee Mile	11.17
Location	Water Side
Category	Supplemental
Item	USACE Erosion Survey

Levee Mile Report Line	46
Start Levee Mile	11.09
End Levee Mile	11.17
Location	Water Side
Category	Supplemental
Item	USACE Erosion Survey
USACE 2012 Photo #3	
USACE2013_BER_1-9_L_3.jpg

Levee Mile Report Line	46
Start Levee Mile	11.09
End Levee Mile	11.17
Location	Water Side
Category	Supplemental
Item	USACE Erosion Survey
USACE 2012 Photo #4	
USACE2013_BER_1-9_L_4.jpg

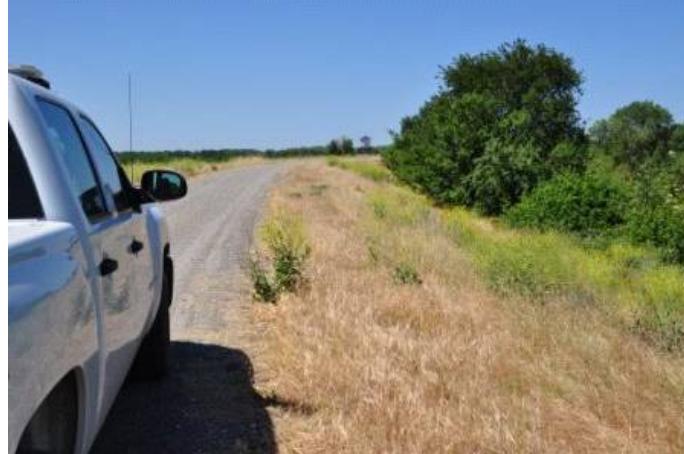
Levee Mile Report Line	49
Start Levee Mile	11.46
End Levee Mile	11.61
Location	Water Side
Category	Earthen Levee
Item	Trim / Thin Trees
RD 1001 Unit 3 - W/S slope - Trim Trees	
mhoffman_f_20130917_199.JPG

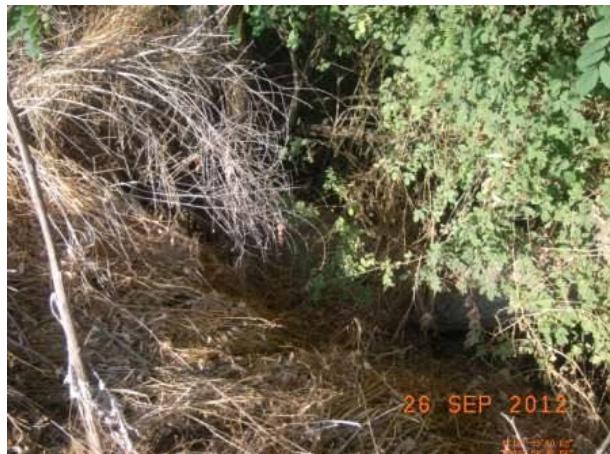
USACE 2012 Photo #3

Levee Mile Report Line	52
Start Levee Mile	12.13
End Levee Mile	12.22
Location	Water Side
Category	Supplemental
Item	USACE Erosion Survey

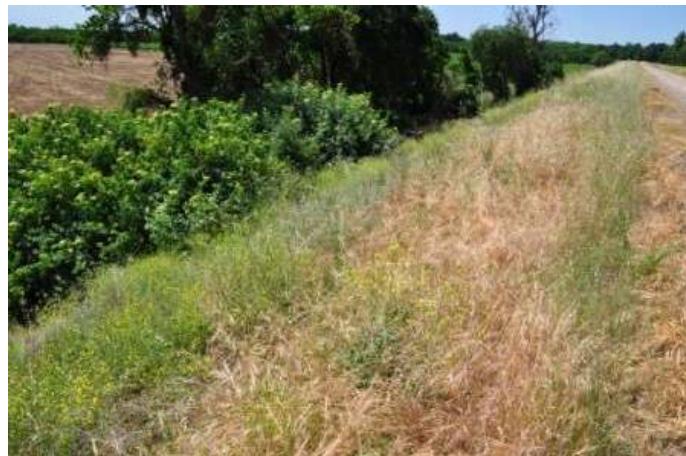
Levee Mile Report Line	53
Start Levee Mile	12.24
End Levee Mile	12.24
Location	Land Side
Category	Earthen Levee
Item	Vegetation

RD 1001 Unit 3 - L/S slope -Elderberries @ toe.

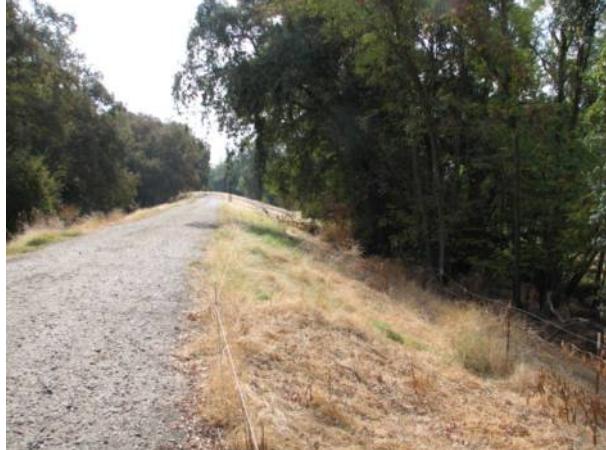
This photo shows the waterside vegetation at levee mile 0.00.

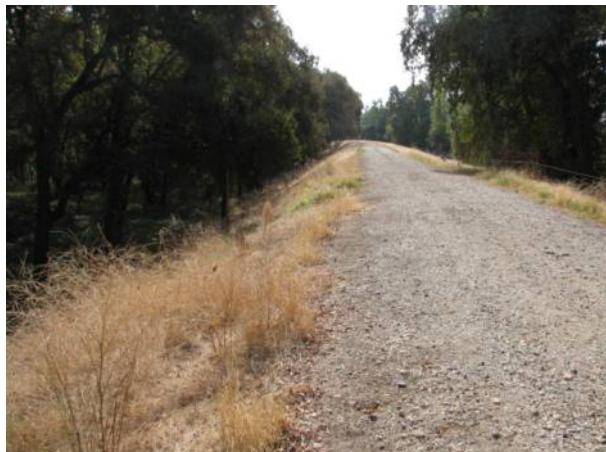
Levee Mile Report Line	2
Start Levee Mile	0.03
End Levee Mile	2.00
Location	Land Side
Category	Earthen Levee
Item	Vegetation

This photo shows the landside vegetation at levee mile 0.00.

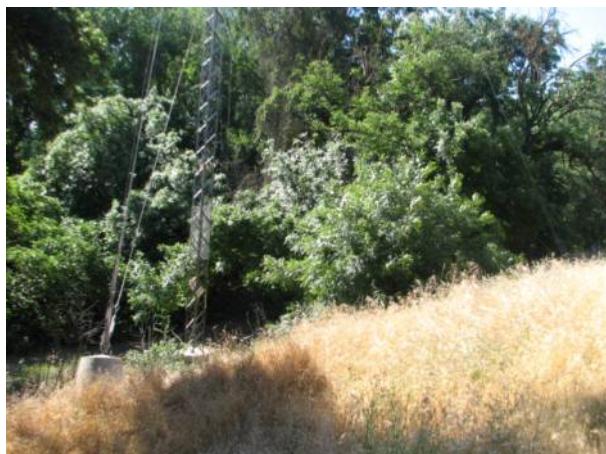
Levee Mile Report Line	4
Start Levee Mile	2.32
End Levee Mile	2.32
Location	Land Side
Category	Earthen Levee
Item	Encroachments

Power pole and guy wire on the levee slope.
Spring 2013

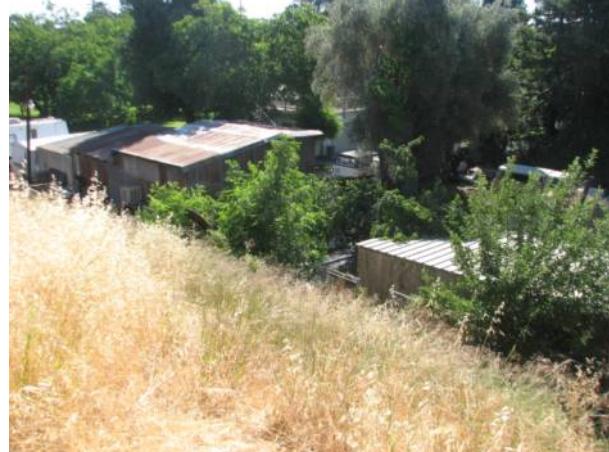
Levee Mile Report Line	5
Start Levee Mile	2.66
End Levee Mile	2.66
Location	Land Side
Category	Earthen Levee
Item	Encroachments
Buildings along the toe within the easement of the levee. Spring 2013	mhoffman_f_20130917_243.JPG

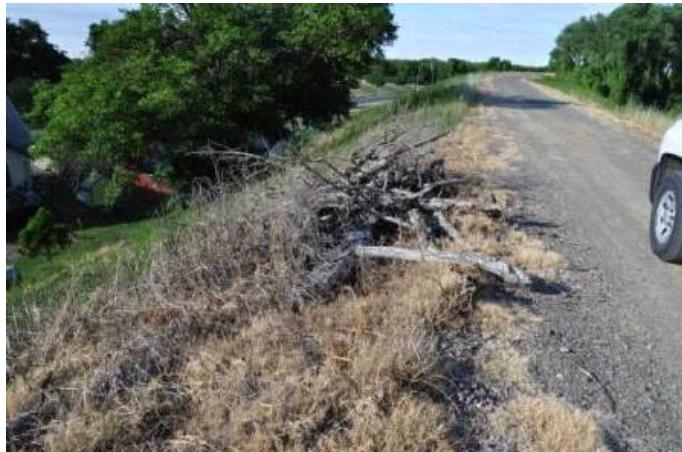
Levee Mile Report Line	6
Start Levee Mile	2.88
End Levee Mile	2.88
Location	Land Side
Category	Earthen Levee
Item	Encroachments
RD 1001 Unit 4 - L/S slope - Limb/Wood Pile.	mhoffman_f_20130917_257.JPG

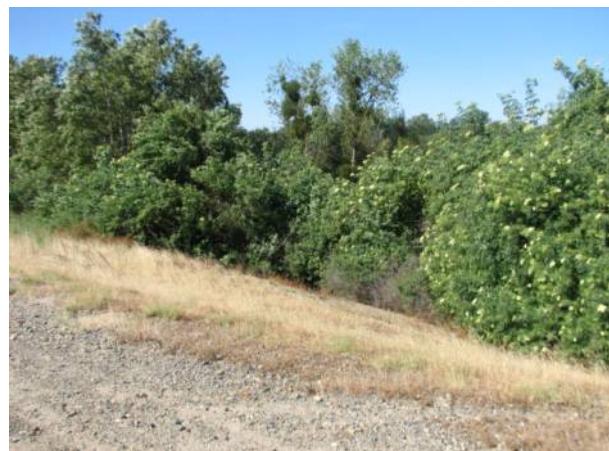
Levee Mile Report Line	9
Start Levee Mile	5.05
End Levee Mile	5.05
Location	Water Side
Category	Earthen Levee
Item	Vegetation
Elderberry Spring 2013	mhoffman_f_20130917_251.JPG

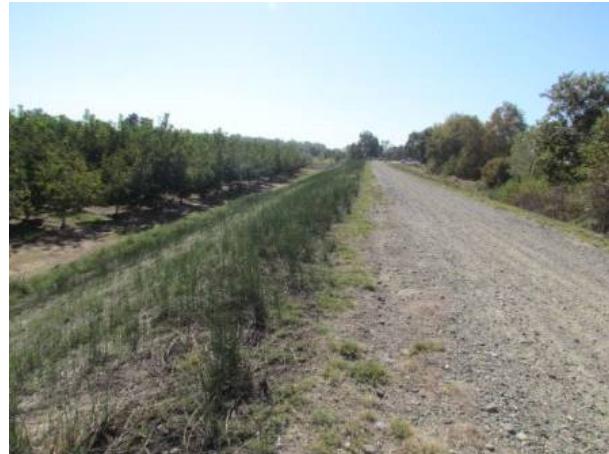
This photo was taken from the levee crown facing west looking down at the vegetation on the landward slope.

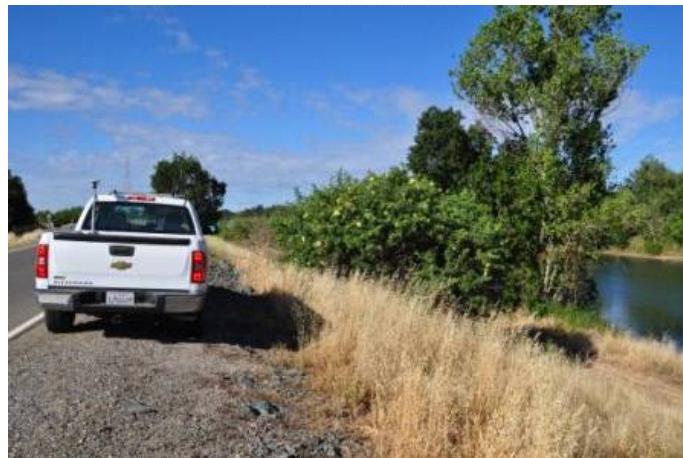
DWR ID: DWR_RD1001_04_f_2013_42
11	5.60	5.60	Earthen Levee	Vegetation	WSA/W En	V4	Elderberries are blocking visibility and flood fight capability.	38.877312 ° -121.613077 °	38.877312 ° -121.613077 °	149 Y
										DWR ID: DWR_RD1001_04_s_2012_149
12	5.84	5.97	Supplemental USACE Erosion Survey	WS Ma	M	V4	Inspector Comments: 2011 - Erosion pockets from tree popouts. Sections of the lower bank have slumped off. 2012: No observed change. [2012 Site ID: FHR_6-6_L]	38.874113 ° -121.615380 °	38.872373 ° -121.616504 °	1 Y
										DWR ID:

Levee Mile Report Line	11
Start Levee Mile	5.60
End Levee Mile	5.60
Location	Water Side
Category	Earthen Levee
Item	Vegetation

RD 1001 Unit 4 - W/S slope - Elderberries

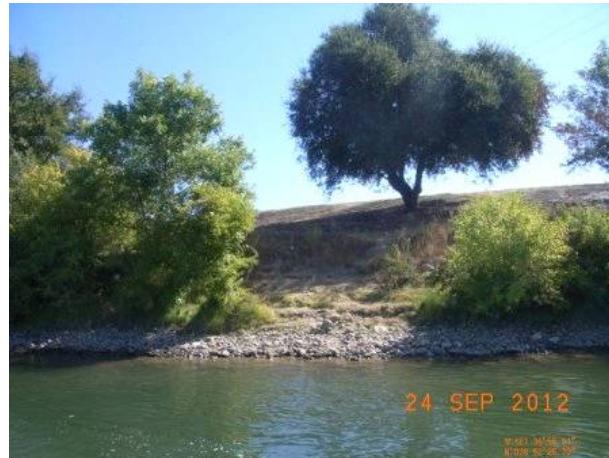
USACE 2012 Photo #1

Levee Mile Report Line	12
Start Levee Mile	5.84
End Levee Mile	5.97
Location	Water Side
Category	Supplemental
Item	USACE Erosion Survey

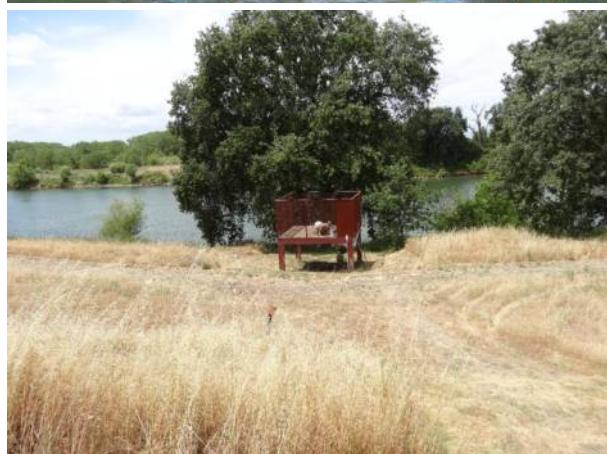
Levee Mile Report Line	14
Start Levee Mile	5.84
End Levee Mile	5.84
Location	Water Side
Category	Supplemental
Item	DWR UCIP Field Study

WS- slanted pump station on steel platform on levee berm.

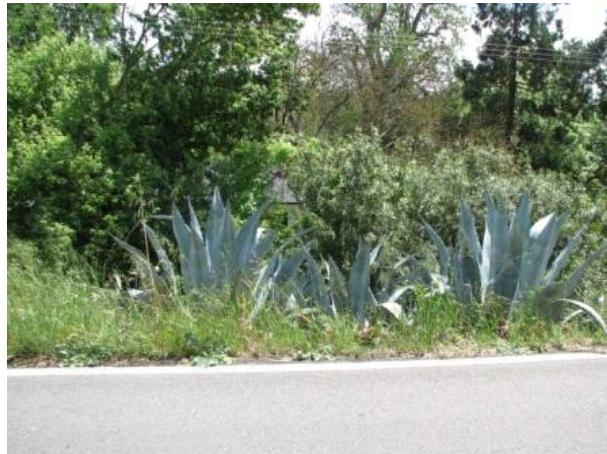
Levee Mile Report Line	16
Start Levee Mile	6.48
End Levee Mile	6.48
Location	Land Side
Category	Earthen Levee
Item	Vegetation

Landscaping on the landside shoulder and slope levee mile 6.48.

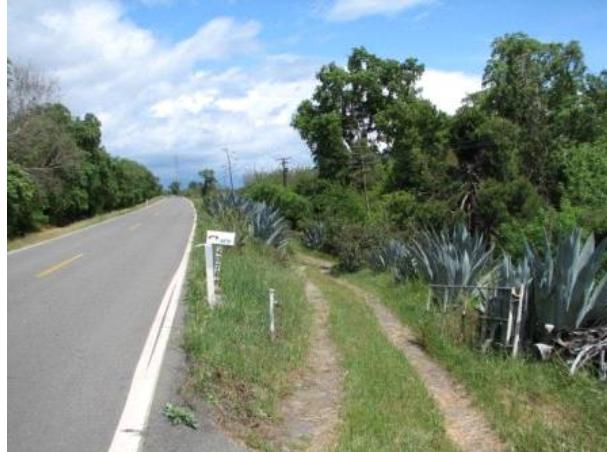
Levee Mile Report Line	16
Start Levee Mile	6.48
End Levee Mile	6.48
Location	Land Side
Category	Earthen Levee
Item	Vegetation
Landscaping levee mile 6.48.	
mhoffman_f_20130917_241.jpg

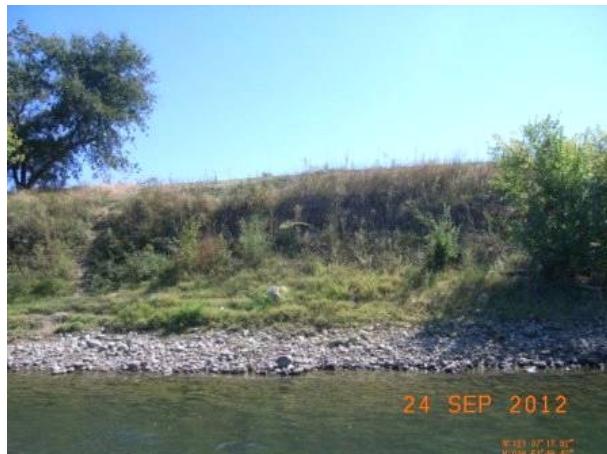
USACE 2012 Photo #1

16	6.48	6.48	Earthen Levee	Vegetation	LS En	M	V6 : Landscaping	38.865653 ° -121.619742 °	38.865653 ° -121.619742 °	17	
17	6.63	6.88	Supplemental USACE Erosion Survey	WS	Ma	M	Inspector Comments: 2011 - Large slumped sections on the lower bank. 2012: No observed change. [2012 Site ID: FHR_5-8_L]	38.863946 ° -121.621388 °	38.861558 ° -121.623316 °	4	
18	6.64	6.64	Earthen Levee	Vegetation	LS Ma	M	V4 : Elderberries are blocking visibility and flood fight capability.	38.863700 ° -121.621198 °	38.863700 ° -121.621198 °	18	
19	6.86	6.86	Earthen Levee	Vegetation	WSA/W Ma	V8	: Environmental Requirements.	38.861071 ° -121.623332 °	38.861071 ° -121.623332 °	28

Levee Mile Report Line	17
Start Levee Mile	6.63
End Levee Mile	6.88
Location	Water Side
Category	Supplemental
Item	USACE Erosion Survey

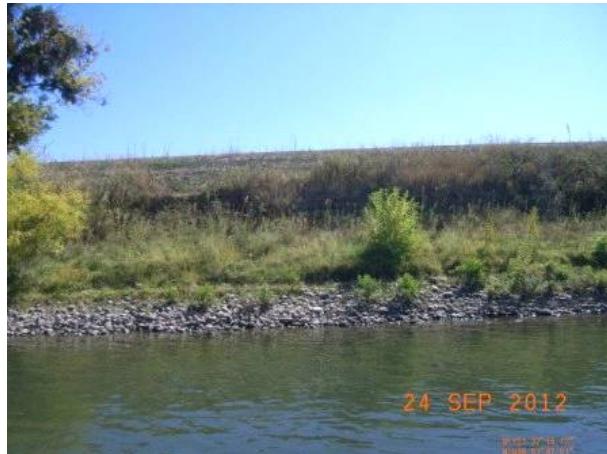
USACE 2012 Photo #2

Levee Mile Report Line	17
Start Levee Mile	6.63
End Levee Mile	6.88
Location	Water Side
Category	Supplemental
Item	USACE Erosion Survey

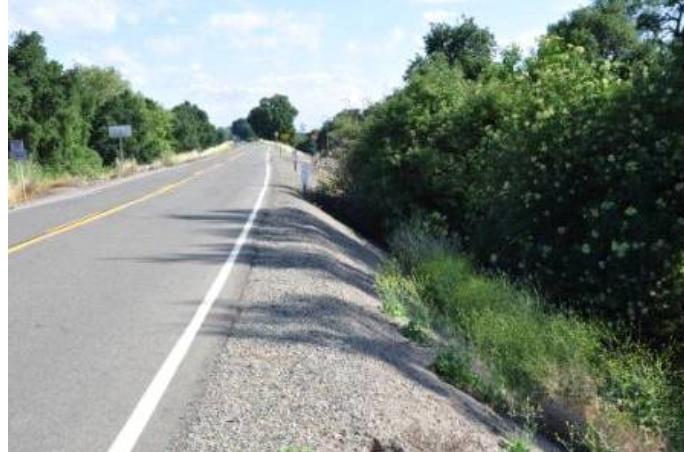
mhoffman_f_20130917_236.JPG

RD 1001 Unit 4 - W/S slope - Elderberries

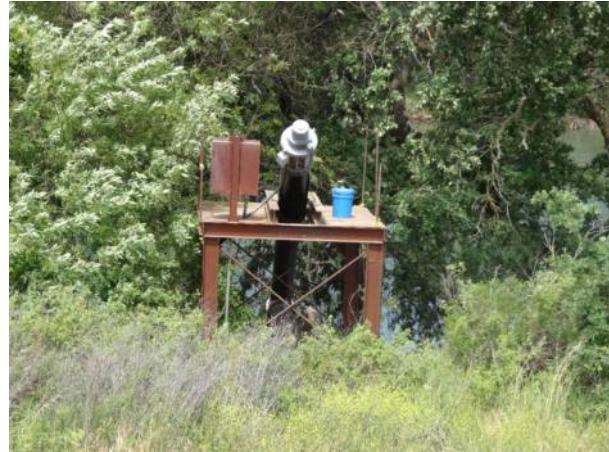
UCIP_7739.jpg

Levee Mile Report Line	24
Start Levee Mile	9.22
End Levee Mile	9.22
Location	Land Side
Category	Supplemental
Item	DWR UCIP Field Study

WS- slanted pipe in steel structure on river bank.

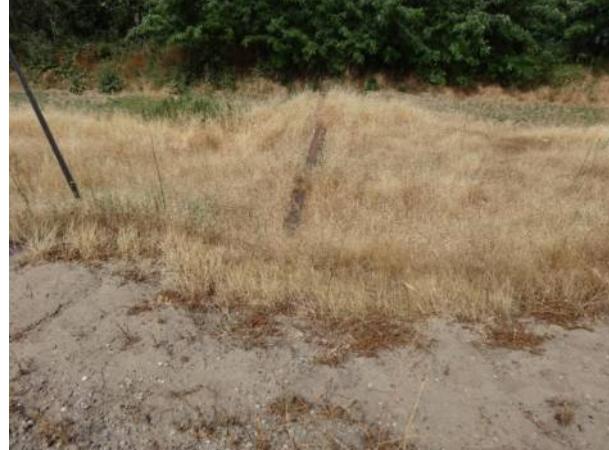
Levee Mile Report Line	25
Start Levee Mile	9.51
End Levee Mile	9.51
Location	Land Side
Category	Supplemental
Item	DWR UCIP Field Study
WS- damaged pipe with holes, cracks on levee slope. River bank is not visible due to dense vegetation (top)	UCIP_7720.jpg

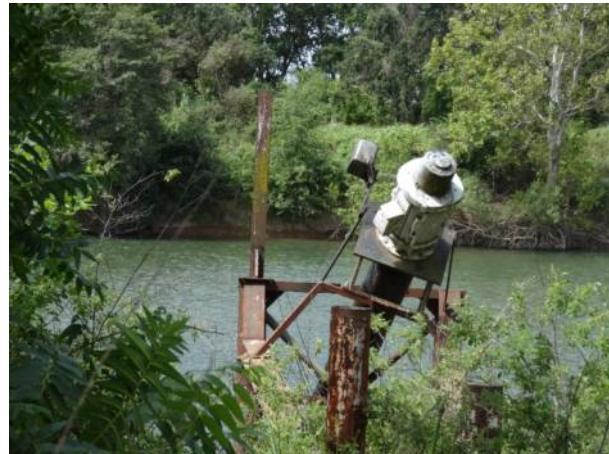
Levee Mile Report Line	28
Start Levee Mile	9.99
End Levee Mile	9.99
Location	Water Side
Category	Supplemental
Item	DWR UCIP Field Study
WS- abandoned slanted pump station in steel pipe structure in river bank.	UCIP_7784.jpg

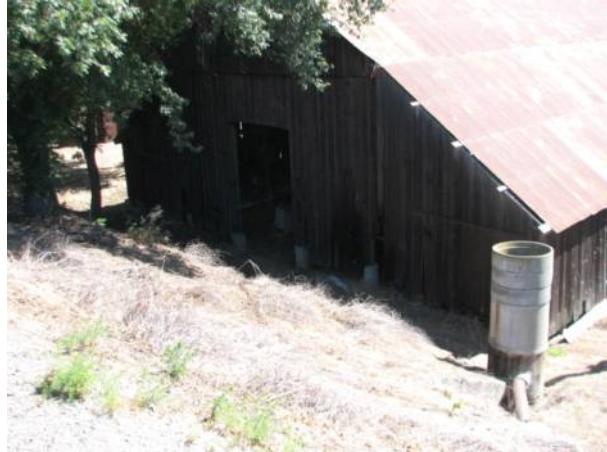
Levee Mile Report Line	33
Start Levee Mile	10.68
End Levee Mile	10.68
Location	Land Side
Category	Earthen Levee
Item	Encroachments
The building is within the easement of the levee. Spring 2013	
mhoffman_f_20130917_253.JPG

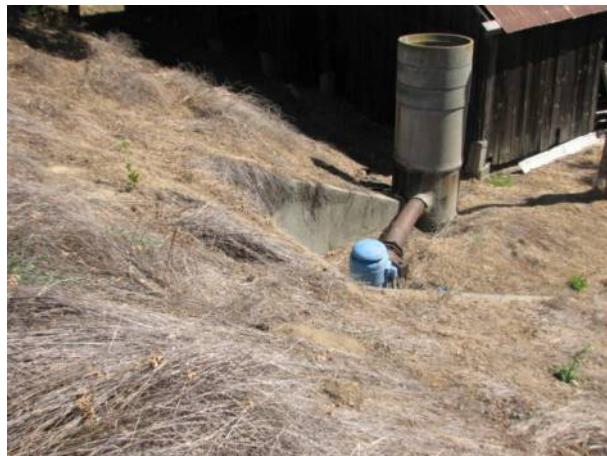
Levee Mile Report Line	34
Start Levee Mile	10.68
End Levee Mile	10.68
Location	Land Side
Category	Earthen Levee
Item	Encroachments
A retaining wall is within the profile of the slope. Spring 2013	
mhoffman_f_20130917_254.JPG

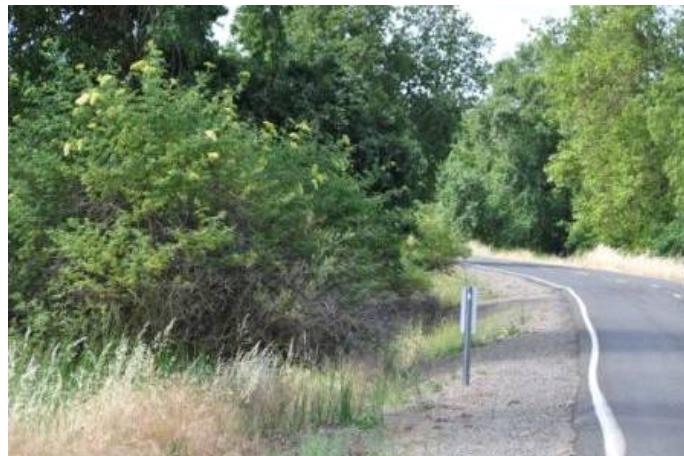
Levee Mile Report Line	35
Start Levee Mile	11.15
End Levee Mile	11.15
Location	Land Side
Category	Earthen Levee
Item	Vegetation
RD 1001 Unit 4 - L/S slope - Elderberries	
mhoffman_f_20130917_245.JPG

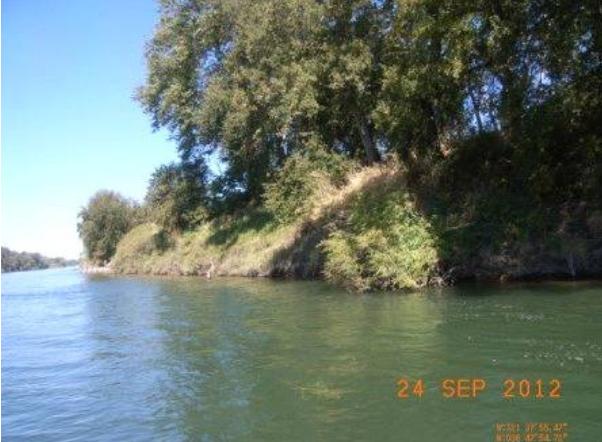
USACE 2012 Photo #1

Levee Mile Report Line	36
Start Levee Mile	11.21
End Levee Mile	11.44
Location	Water Side
Category	Supplemental
Item	USACE Erosion Survey

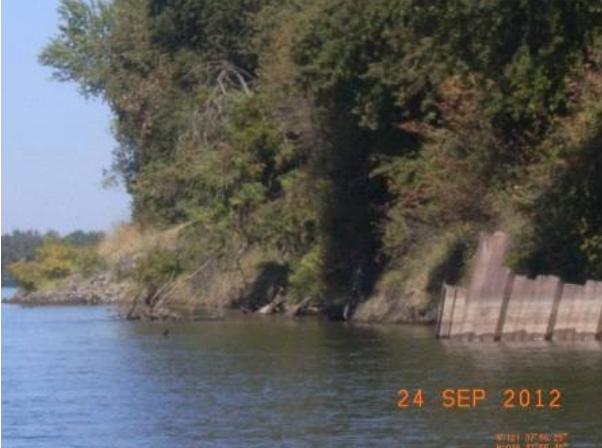
USACE 2012 Photo #2

Levee Mile Report Line	36
Start Levee Mile	11.21
End Levee Mile	11.44
Location	Water Side
Category	Supplemental
Item	USACE Erosion Survey

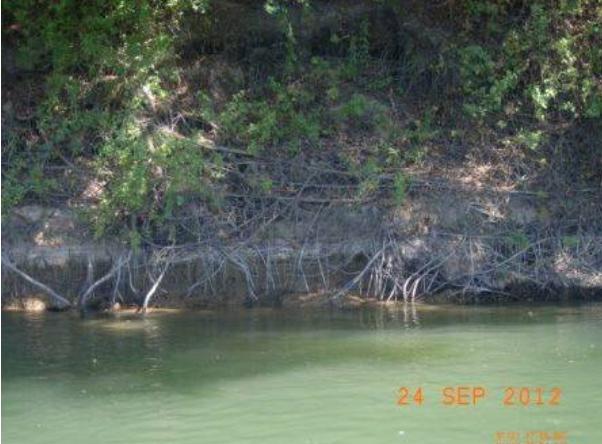
USACE 2012 Photo #3

Levee Mile Report Line	36
Start Levee Mile	11.21
End Levee Mile	11.44
Location	Water Side
Category	Supplemental
Item	USACE Erosion Survey

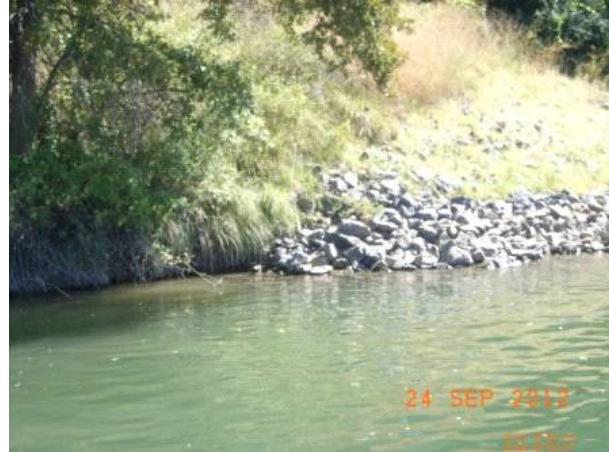
Levee Mile Report Line	36
Start Levee Mile	11.21
End Levee Mile	11.44
Location	Water Side
Category	Supplemental
Item	USACE Erosion Survey
USACE 2012 Photo #4	
USACE2013_FHR_1-0_L_4.jpg

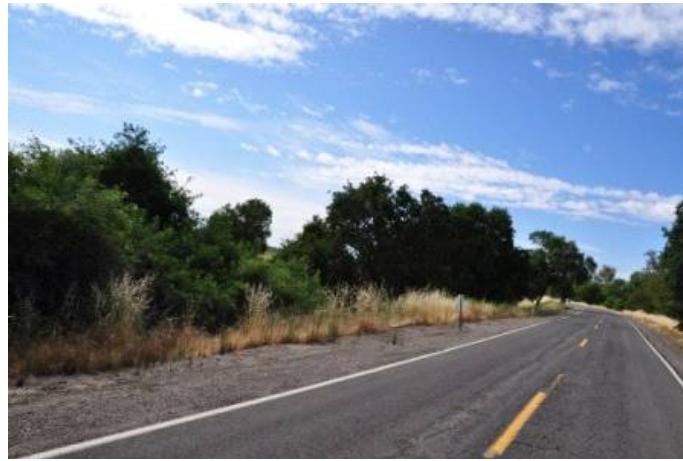
Levee Mile Report Line	37
Start Levee Mile	11.32
End Levee Mile	11.32
Location	Land Side
Category	Earthen Levee
Item	Vegetation
RD 1001 Unit 4 - L/S slope - Elderberries	
mhoffman_f_20130917_246.JPG

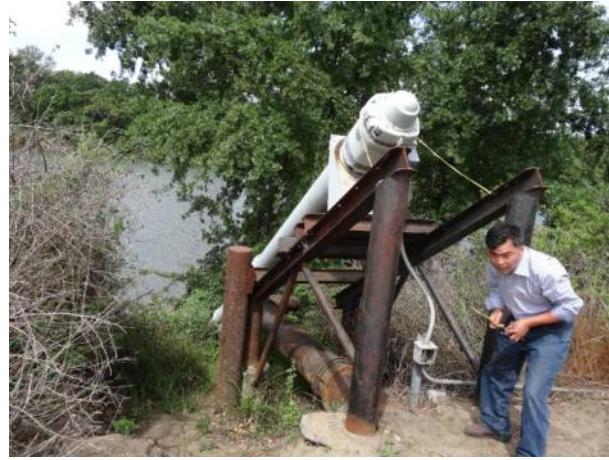
Levee Mile Report Line	39
Start Levee Mile	11.36
End Levee Mile	11.36
Location	Land Side
Category	Supplemental
Item	DWR UCIP Field Study
WS- slant pump, pipe on steel piles.	
UCIP_7704.jpg

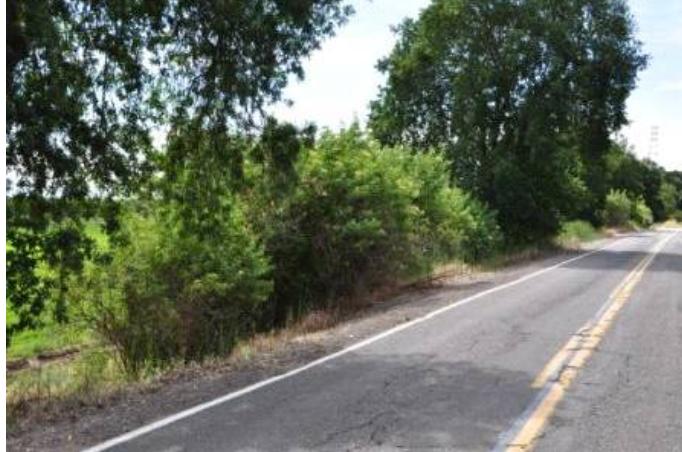
Levee Mile Report Line	42
Start Levee Mile	12.40
End Levee Mile	12.49
Location	Land Side
Category	Earthen Levee
Item	Vegetation
RD 1001 Unit 4 - L/S slope - Elderberries	
mhoffman_f_20130917_247.JPG

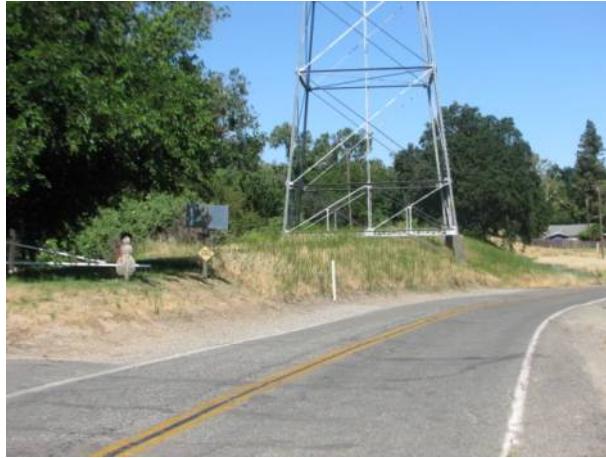
Levee Mile Report Line	43
Start Levee Mile	12.57
End Levee Mile	12.57
Location	Land Side
Category	Earthen Levee
Item	Encroachments
A short section of the levee (12.47-12.70) has limited access. Spring 2013	
mhoffman_f_20130917_249.JPG

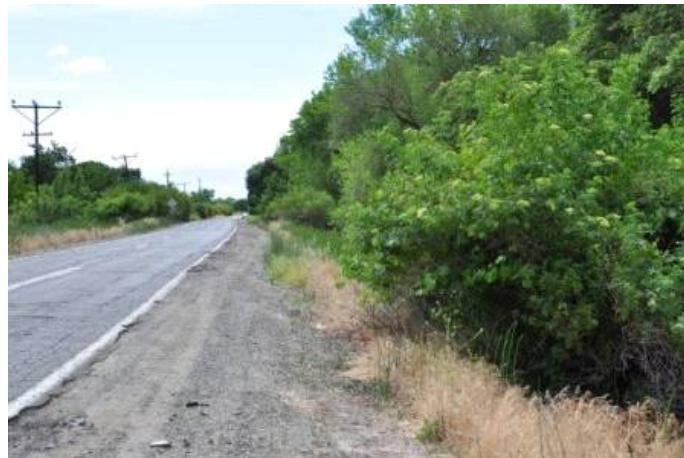
Levee Mile Report Line	44
Start Levee Mile	12.74
End Levee Mile	13.22
Location	Land Side
Category	Earthen Levee
Item	Vegetation
RD 1001 Unit 4 - W/S slope - Elderberries	
mhoffman_f_20130917_250.JPG

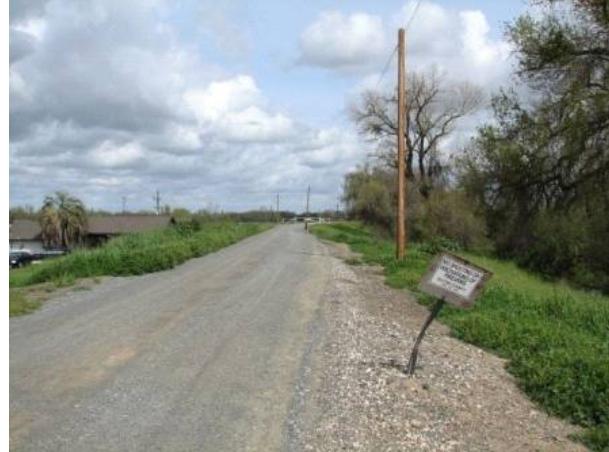
Levee Mile Report Line	1
Start Levee Mile	0.00
End Levee Mile	0.75
Location	Water Side
Category	Earthen Levee
Item	Encroachments
Poles on the water side shoulder levee mile 0.00 - 0.75	mhoffman_f_20130917_260.jpg

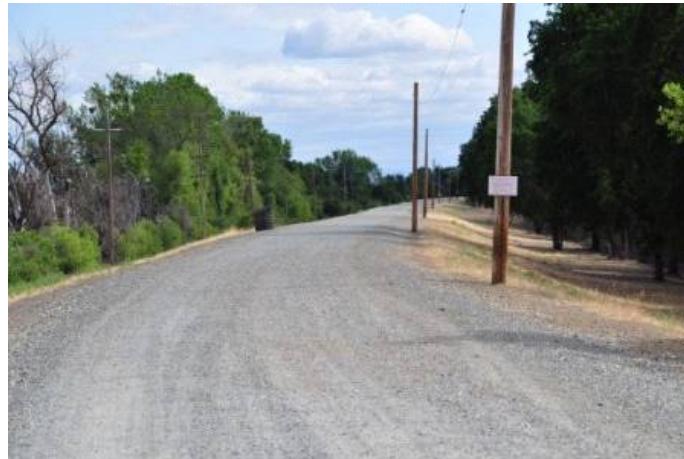
Levee Mile Report Line	1
Start Levee Mile	0.00
End Levee Mile	0.75
Location	Water Side
Category	Earthen Levee
Item	Encroachments
RD 1001 Unit 5 - W/S Levee Shoulder - Poles	mhoffman_f_20130917_261.JPG
